**Materials Reliability Program
Resistance to Primary Water Stress Corrosion
Cracking of Alloys 690, 52, and 152 in Pressurized
Water Reactors (MRP-111)**

1009801

Technical Update, March 2004

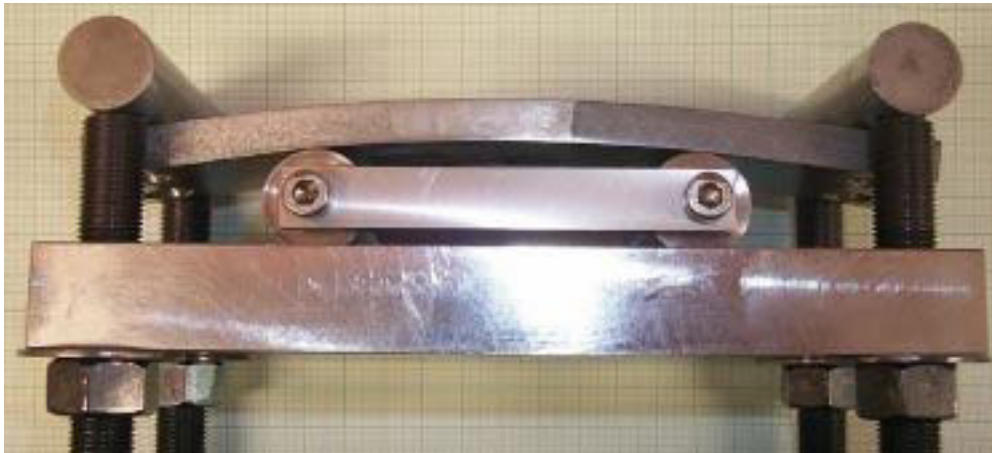
Figure 3-16 Four-Point Bend Specimen Configuration.^[54]

The specimens were prepared as flat plates and bolt-loaded in specially designed four-point bending fixture as shown in Figure 3-16. The Alloy 182 weld specimens and the Alloy 52M weld specimens have the same dimensions. They were 180-mm long x 40-mm wide x 9-mm thick plates in which the welds were transverse to the long dimension. The Alloy 600 specimens were 102-mm long x 19-mm wide x 3.8-mm thick strips. The specimens were taken at locations of varying depths from the surface. The microstructure has been observed to vary through the wall of the nozzle. This permits the possibility that the SCC response may be influenced by heterogeneity of the microstructure or possible differences in the manufacturing-related deformation. Two strain/stress levels were tested in this program.

In a four-point bend specimen configuration (Figure 3-16), the stresses and strains are constant between the inner supports. With the bent beam configuration, the entire weld and all microstructural features can be located within the inner supports, ensuring that the strain (and stress) is uniform, and that SCC is less likely to initiate at a location unique to the test article configuration. The stresses measured for these specimens at various stages in the test program are summarized in Table 3-51. These elastic stresses were calculated, using the 400°C elastic modulus of Alloy 600 (195.3 GPa), from the strains released as the specimens were unloaded. The "low" stress values are approximately equal to the yield strengths of the test materials, typically in the range from 320 to 440 MPa. These stresses remained, even at the completion of the autoclave exposures; stress relaxation did not appear to be a significant factor. The residual stresses for the "high" stress specimens averaged 431 to 456 MPa for the Alloy 600 and Alloy 52M specimens. Significantly higher stresses, 568 to 586 MPa, were measured for the Alloy 182 specimens, related perhaps to the higher yield strength and higher initial work-hardening rate for this weld metal.

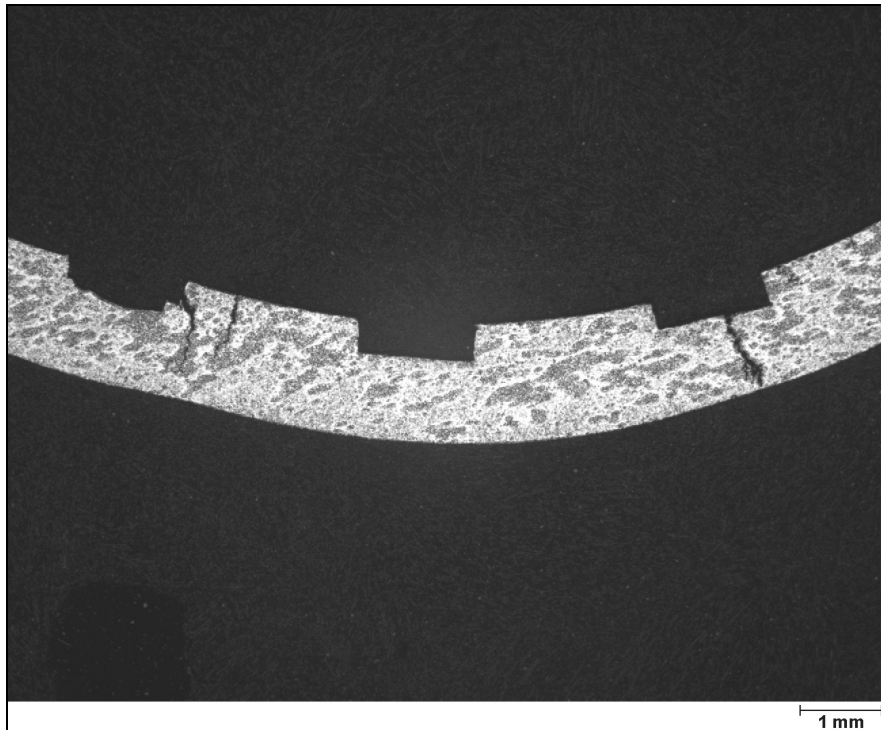
Figure A-10 Typical view of scored Alloy 600MA metallographic specimen exhibiting numerous cracks, some of which had developed into through-wall defects.

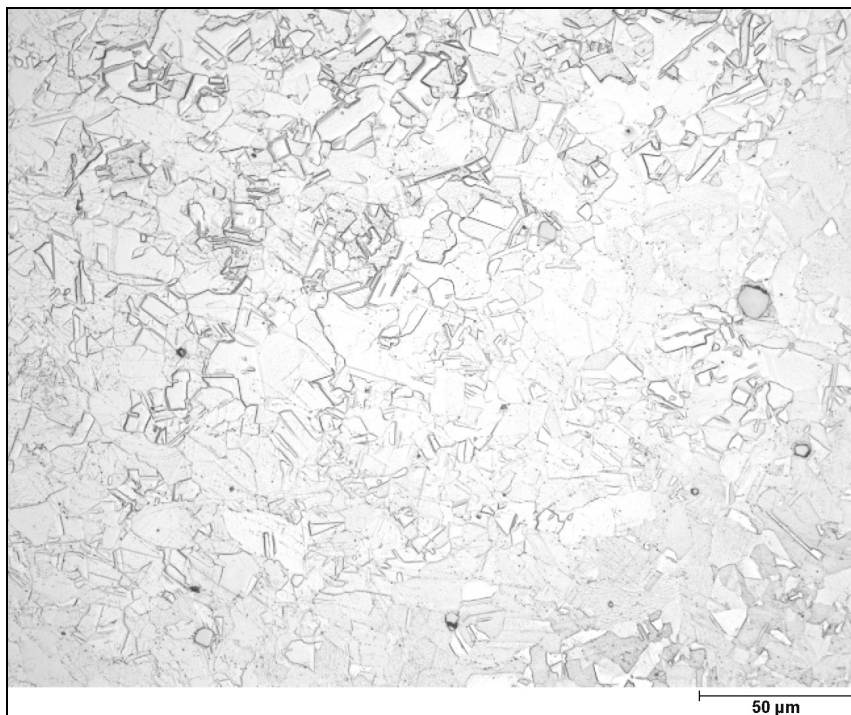
Figure A-12 General microstructure found in Alloy 600MA specimens displaying a typical austenitic appearance. The grain size according ASTM E 112 was determined to be 8.5.

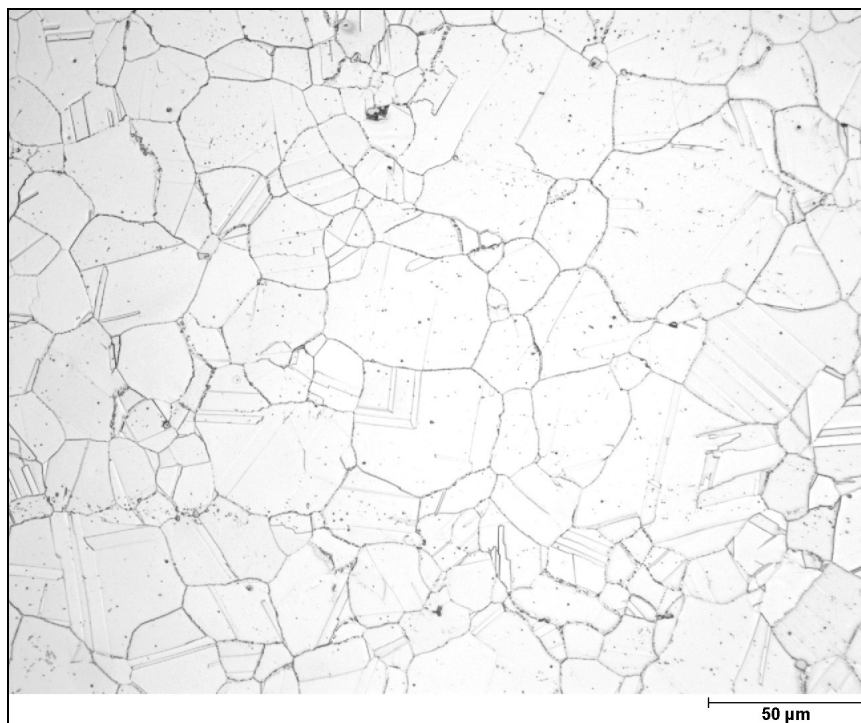
Figure A-19 General microstructure of Alloy 690TT displaying some intragranular carbides and a semi-continuous to continuous network of grain boundary carbide precipitates as a result of the thermal treatment. The grain size for this material ranged between 5 and 7.

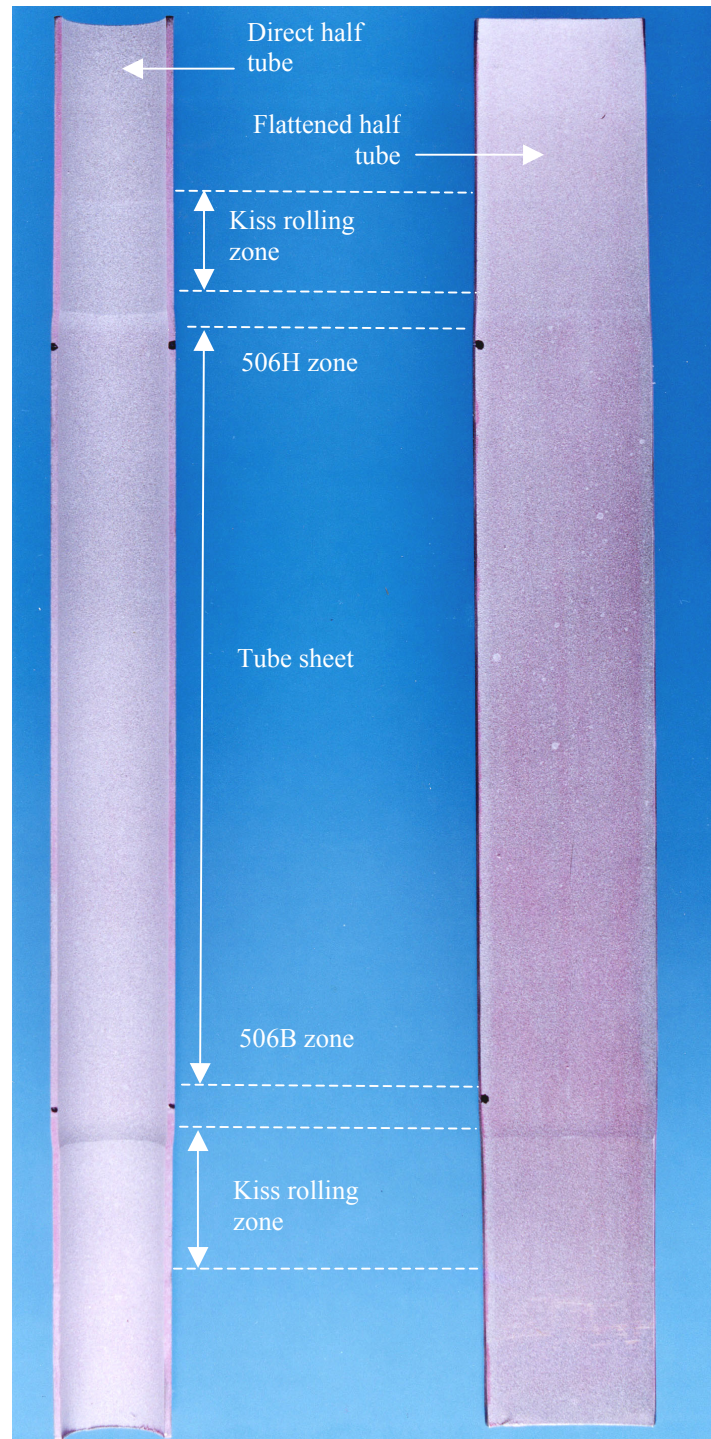
Figure B-6 Liquid penetrant test on mock-up 506. View of the two half tubes after splitting the mock-up longitudinally (the right hand half is flattened, the other is not flattened).
